CaseStudy

Starclean Belt Cleaner

November 2016

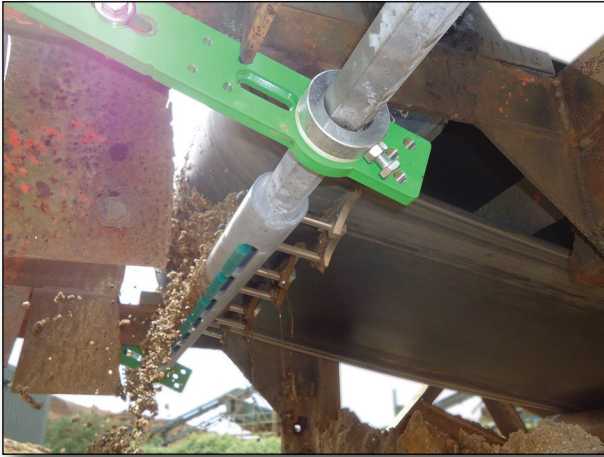
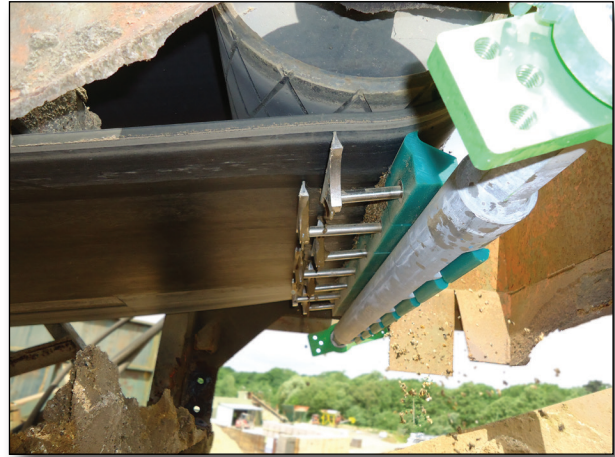
The Challenge: A large sand and gravel pit handling 0-5 mm grit was experiencing serious carryback problems caused by an ineffective belt scraper. This led to conveyor belt mistracking, premature component wear, loss of material and significant clean-up costs with attendant safety concerns.

Our Solution: **Starclean 53sn secondary cleaner with integrated PU primary lip in underbelt location with 800 series quick release tensioner**

Key Features: Integrated PU lip acts as a pre-clean to remove heavier carryback
High efficiency tungsten blades remove fines and moisture
Every blade tensioned against the belt independently of each other
Quick release tensioner & slot-in blades allow maintenance in seconds

Improvements: Belt now spotlessly clean. No maintenance required since installation
