# **Encyclis ERF quadruples** conveyor runtime by installing STARCLEAN®

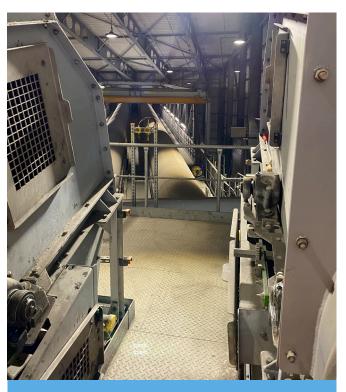
2 belt conveyor streams handling incinerator bottom ash (IBA)

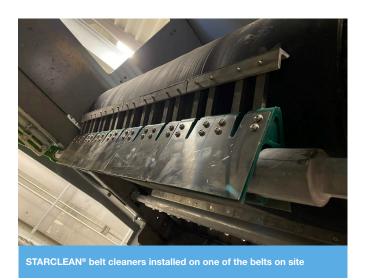
IBA can be extremely difficult to handle due to its complex composition of materials such as; glass, metal and unburned residual waste. The troublesome material, coupled with ineffective belt scrapers on the conveyors, resulted in significant carryback problems - particularly on and around the head drum. This limited how long a conveyor stream could operate before intervention was required and, resulted in the streams being switched prematurely every 3-4 days to allow for maintenance.

Across both streams, it would then take the contractors 4 full days following every change to remove the IBA carryback from around the head drum, under the belts and the adjacent walkways.

Example of incinerator bottom ash build-up under belt head drum

To combat the high levels of carryback and the effects of the abrasive IBA, two STARCLEAN® belt cleaners were trialled on a belt. A primary cleaner was specified with 286nl blades. In addition to tungsten carbide tips, the blades have a protective apron over the mounting feet to prevent premature wear. For the secondary cleaner, heavy duty 09hm tungsten carbide blades were selected and fitted to a reinforced blade base to tackle the remaining fines.

Following positive results from the trial, the Maintenance Manager decided to install STARCLEAN® belt cleaners on all 4 of the belts.

Similarly, before STARCLEAN®, the time spent cleaning and maintaining both streams of conveyors was 4 days with the head drum, underbelly and walkways requiring the attention of the on-site contracted company. With STARCLEAN®, cleaning time has been reduced to just 2 days across both streams - a 50% decrease in time. Additionally, the amount of carryback needing to be cleared has been more than halved.
