Cement plant turns to ProSpare to improve belt conveyor performance

The challenge

A major UK dry process cement plant, operating since the 50's, extracts over 1m tonnes of carboniferous limestone annually. A network of +40 belt conveyors operate across the quarry and cement plant that are critical to the success of the entire facility.

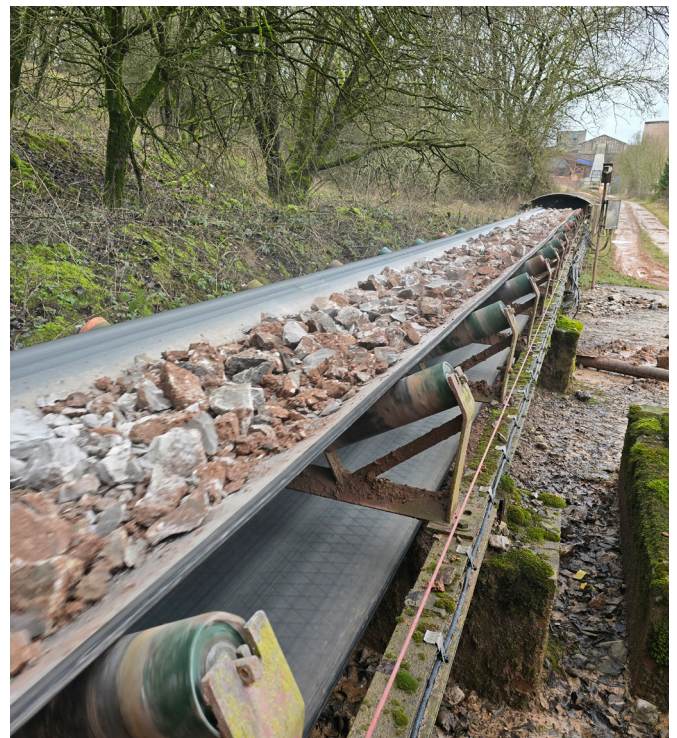
Conveyor transporting 100mm limestone at 700-800 T/P/H
